# Broomfield Parish Council

## Agenda

- 1.1 A site visit was carried out by Adam Sultan (Place Services' Arboricultural Consultant) on 7<sup>th</sup> April 2026 to inspect trees in line with the instruction from Broomfield Parish Council. Unless otherwise stated, all trees were inspected visually from ground level. The nature of the survey was to assess the site for risks from tree-related hazards and to recommend any necessary work to control these risks.

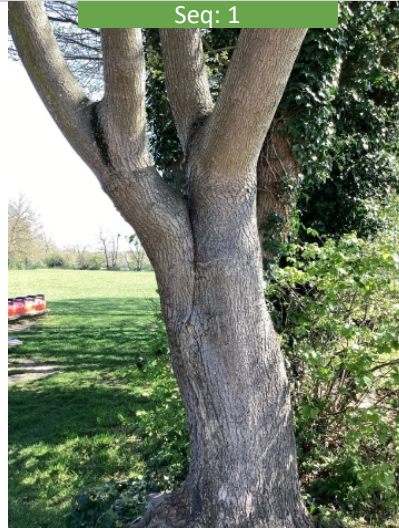
| Seq No | Tree Position | Common Name | Bat PRFs | Height (m) | Age | Stru cond. | Conditions | Recommendations | Priority | Comments | Next S/T Inspect |
|---|---|---|---|---|---|---|---|---|---|---|---|
| 1 | Adjacent play area, green bin, car park, benches | Sycamore | No | 12 | Mature | Fair | · Trunk - Weak union<br>· Trunk - Compression fork<br>· Trunk - Included bark - probe can currently be inserted 5cm | Re-inspect compression fork union | 18 months | T1 on previous report. Mature tree in fair structural condition and good physiological condition. The tree has a compression fork at the crown break at 1.7m, with included bark, a probe can currently be inserted 5cm. There is a high target of the play area and footpath, due to this it is recommended to monitor the union before the next scheduled inspection to assess structural integrity. | 01/11/2027 |

T1: Trunk - Compression fork

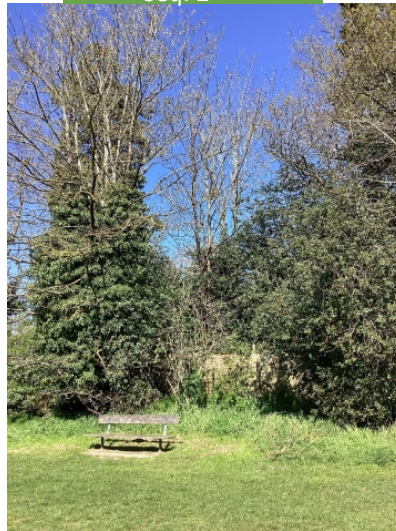
Seq: 2

T2: dead tree

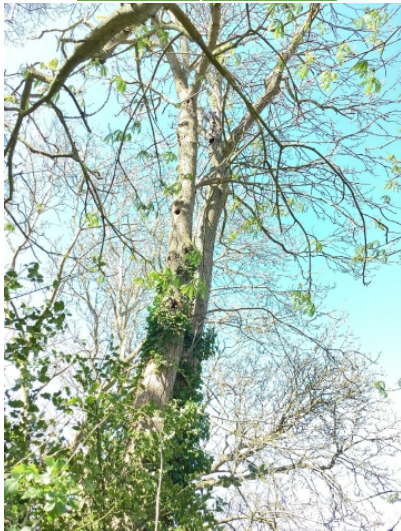
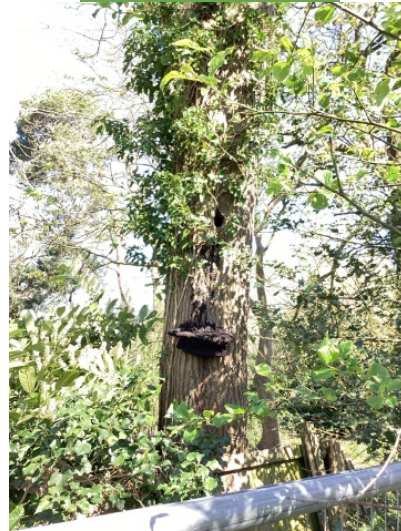
Seq: 3

| Seq No | Tree Position | Common Name | Bat PRFs | Height (m) | Age | Stru cond. | Conditions | Recommendations | Priority | Comments | Next S/T Inspect |
|---|---|---|---|---|---|---|---|---|---|---|---|
| 3 | Off site adjacent T2 Horse Chestnut on previous report | Common Ash | Yes | 16 | Semi-mature | Poor | <ul style="list-style-type: none"> <li>· Crown - Major Deadwood &gt;5cm diam/1m length</li> <li>· Trunk - Major trunk decay</li> <li>· Trunk - Cavity</li> <li>· Trunk - Fungus</li> </ul> | <ul style="list-style-type: none"> <li>· Further Investigation</li> </ul> | Within 30 days | <p>Off site twin stem Ash tree in poor structural condition and fair physiological condition.</p> <p>Multiple woodpecker holes visible along both stems, with <i>Inonotus hispidus</i> (shaggy bracket) wood decay fungi also present, these factors are likely to have caused significant internal decay along the stems, however due to boundary fence no further assessment can be made at present.</p> <p>It is recommended to contact the landowner and request they commission a full inspection of the tree and carry out necessary works as the tree is within falling distance of the public footpath and playing field.</p> | 01/04/2029 |

T3: Trunk cavity

T3: Trunk - Fungus

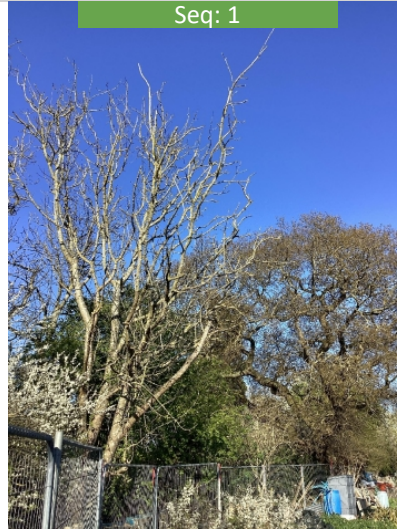
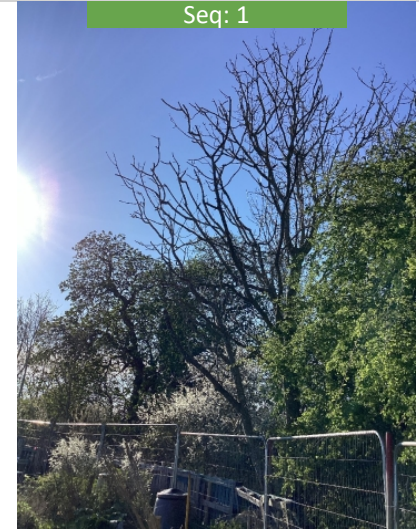
Seq: 1

| Seq No | Tree Position | Common Name | Bat PRFs | Height (m) | Age | Stru cond. | Conditions | Recommendations | Priority | Comments | Next S/T Inspect |
|---|---|---|---|---|---|---|---|---|---|---|---|
| 1 | NW corner of allotments | Common Ash | No | 11 | Semi-mature | Fair | <ul style="list-style-type: none"><li>· Crown - Major Deadwood &gt;5cm diam/1m length</li><li>· Crown - Dieback in upper crown, suspected Ash dieback</li><li>· Ash Health Class 3 - 50% -25% Canopy</li></ul> | <ul style="list-style-type: none"><li>· Remove Deadwood &gt;5cm diam/1m length overhanging allotments</li></ul> | Within 90 days | T1 on previous report. Multi-stem Ash tree in fair overall condition. The tree has suspected Ash dieback, negatively impacting crown vitality, with some deadwood present. Remove deadwood on allotment side of the tree. | 01/04/2029 |

T1: Remove Deadwood >5cm diam/1m length

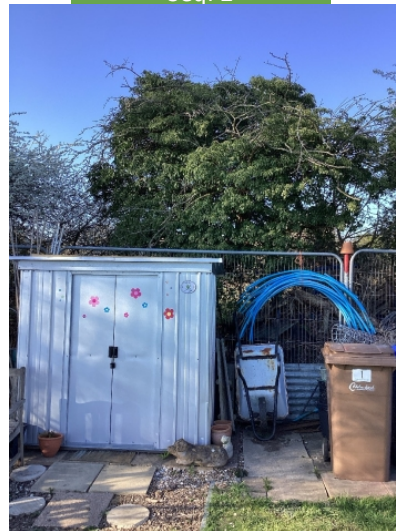
Seq: 2

| Seq No | Tree Position | Common Name | Bat PRFs | Height (m) | Age | Stru cond. | Conditions | Recommendations | Priority | Comments | Next S/T Inspect |
|---|---|---|---|---|---|---|---|---|---|---|---|
| 2 | Adjacent plot 20B / Mel's garden | Hawthorn | No | 5 | Semi-mature | Dead | <ul style="list-style-type: none"><li>· Dead tree</li><li>· Trunk - Ivy</li></ul> | <ul style="list-style-type: none"><li>· Fell Tree to fence height/ 1.5m</li></ul> | Within 90 days | Dead semi-mature ivy clad Hawthorn adjacent shed and within falling distance of allotment. Wood can be left neatly adjacent for habitat potential. | |

T2: Hawthorn

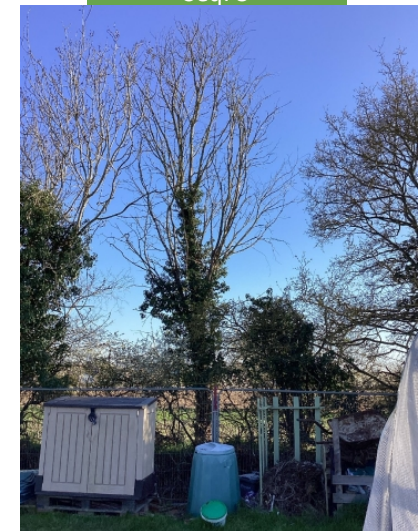
Seq: 3

| Seq No | Tree Position | Common Name | Bat PRFs | Height (m) | Age | Stru cond. | Conditions | Recommendations | Priority | Comments | Next S/T Inspect |
|---|---|---|---|---|---|---|---|---|---|---|---|
| 3 | Behind boundary fence and white storage unit | Elm spp | No | 10 | Young | Dead | <ul style="list-style-type: none"><li>· Dead tree</li><li>· Trunk - Ivy</li></ul> | <ul style="list-style-type: none"><li>· Fell Tree to fence height/ 1.5m</li></ul> | Within 90 days | Dead ivy clad Elm within falling distance of allotments. | |

T3: Elm

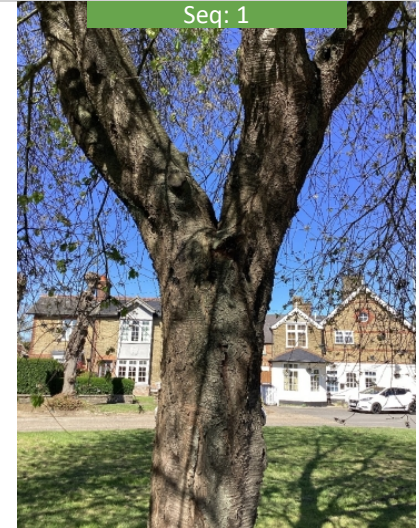
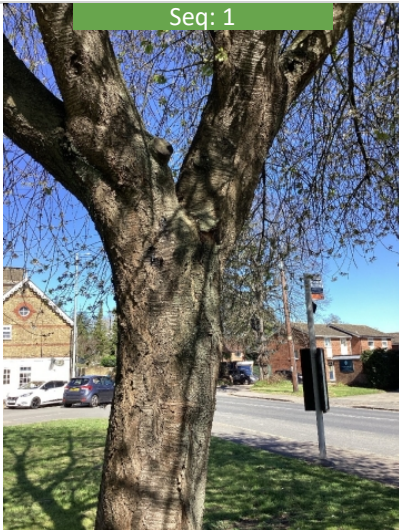
Seq: 1

| Seq No | Tree Position | Common Name | Bat PRFs | Height (m) | Age | Stru cond. | Conditions | Recommendations | Priority | Comments | Next S/T Inspect |
|---|---|---|---|---|---|---|---|---|---|---|---|
| 1 | Adjacent bus stop / black bench | Wild Cherry | No | 11 | Mature | Fair | · Crown - Weak branch Unions | None Recorded. | No action required | T1 on previous report. Mature Cherry tree in fair structural condition with good crown vitality. The tree has recently been crown lifted over the footway as recommended in the previous report. The tree has included bark at the crown break at 2.5m to the S aspect, this is a potential failure point, however at present there is no indication of significant decay when sound tested with a soft faced hammer and probed. No work currently required. | 01/04/2029 |

T1: Crown - Weak branch Unions

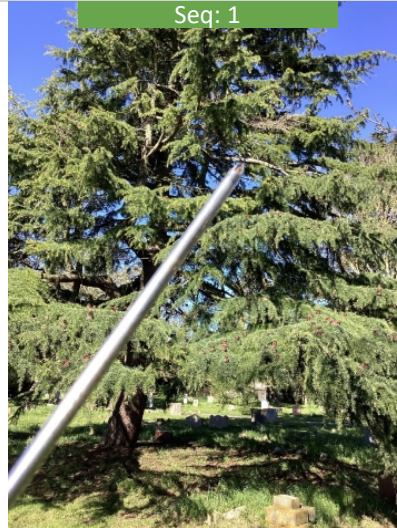
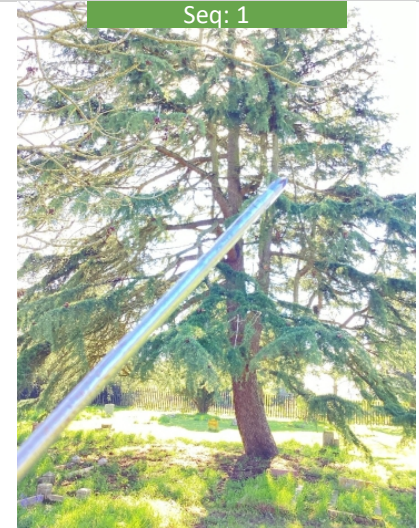
Seq: 1

| Seq No | Tree Position | Common Name | Bat PRFs | Height (m) | Age | Stru cond. | Conditions | Recommendations | Priority | Comments | Next S/T Inspect |
|---|---|---|---|---|---|---|---|---|---|---|---|
| 1 | Centre of Church Yard | Deodar Cedar | No | 12 | Mature | Fair | <ul style="list-style-type: none"> <li>· Crown - Broken hanging branches</li> <li>· Crown - Low branches over graves</li> </ul> | <ul style="list-style-type: none"> <li>· Crown Lift to 3m all round if unrestricted access is required.</li> <li>· Remove broken hanging branches x2</li> </ul> | <p>Within 1 year</p> <p>Within 30 days</p> | <p>Tag 0588. Mature Cedar in fair structural condition and good physiological condition.</p> <p>There are multiple broken branches within the crown, no fungi or disease visually evident on inspection. There are low drooping branches over graves, consistent with the species, an optional crown lift all round to 3m will abate this obstruction if unrestricted access is required in this area.</p> | 01/04/2029 |

T1: Remove broken hanging branch

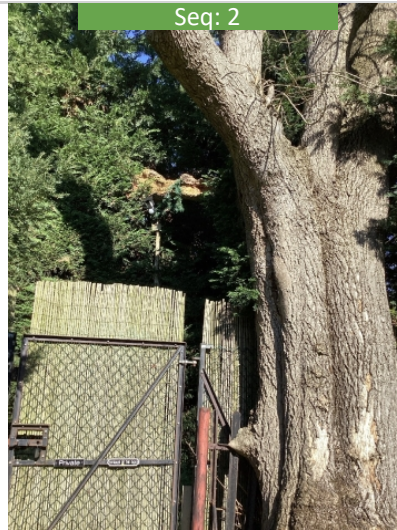
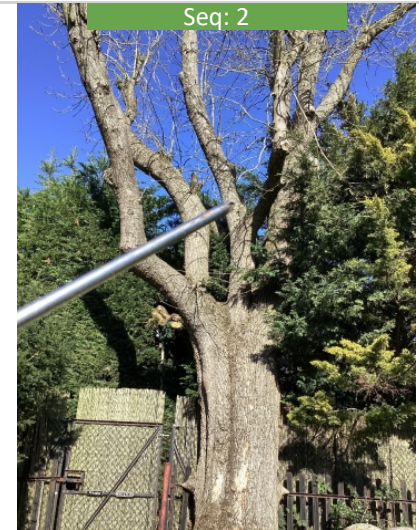
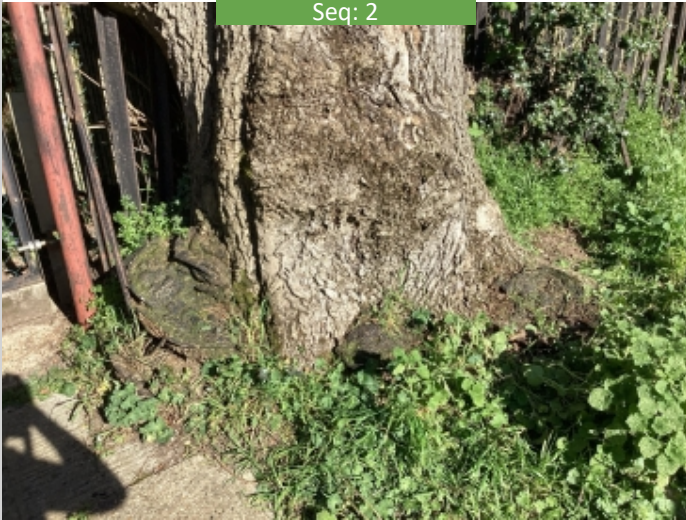
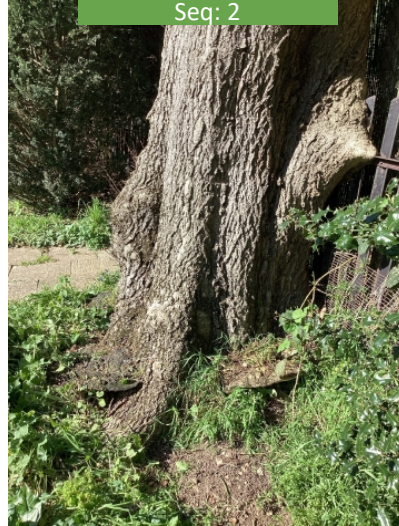
Seq: 2

| Seq No | Tree Position | Common Name | Bat PRFs | Height (m) | Age | Stru cond. | Conditions | Recommendations | Priority | Comments | Next S/T Inspect |
|---|---|---|---|---|---|---|---|---|---|---|---|
| 2 | End of path, adjacent gate | Common Ash | No | 12 | Mature | Poor | <ul style="list-style-type: none"><li>· Crown - Pollard</li><li>· Crown - Significant decay visible on branch growing into adjacent hedge</li><li>· Crown - Fungus - <i>Inonotus hispidus</i> bracket on leading stem 1.5m above crown break</li><li>· Minor trunk decay - Tapping stem from base up to 2m infers minimal decay at present.</li><li>· Trunk - Fungus - <i>Perenniporia fraxinea</i> brackets around all aspects of buttress.</li></ul> | <ul style="list-style-type: none"><li>· Re-inspect in 18 months to assess decay and observe any new fungi.</li></ul> | 18 months | Mature Ash in poor structural condition and fair physiological condition.<br><br>The tree has <i>Perenniporia fraxinea</i> (Giant Ash bracket) fungi brackets around all aspects of buttress. Tapping stem from base up to 2m infers minimal decay at present. Significant branch decay visible on branch growing into adjacent hedge. <i>Inonotus hispidus</i> (Shaggy bracket) bracket on leading stem 1.5m above crown break. The tree has been pollarded, suspected due to fungi and potential structural weakness, with sporadic poor regrowth up to 2m. | 01/10/2027 |

T2: Crown - Branch Decay

T2: Crown - Fungus - Shaggy Bracket

T2: Trunk - Fungus - Giant Ash Bracket

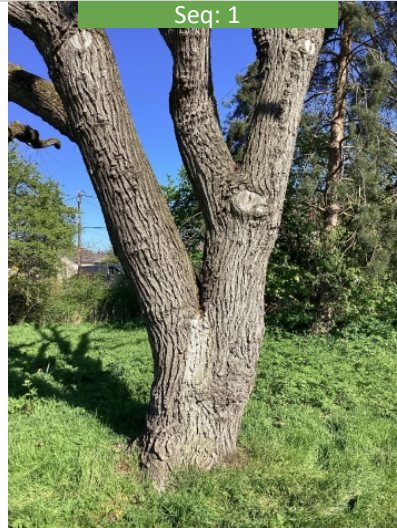
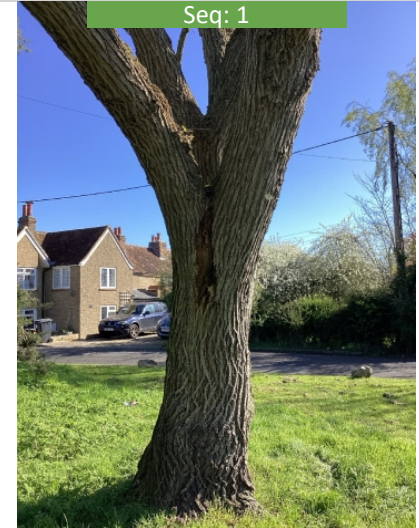
Seq: 1

| Seq No | Tree Position | Common Name | Bat PRFs | Height (m) | Age | Stru cond. | Conditions | Recommendations | Priority | Comments | Next S/T Inspect |
|---|---|---|---|---|---|---|---|---|---|---|---|
| 1 | Approximately 10m NW of Broomfield sign | Elm spp | No | 12 | Mature | Fair | <ul style="list-style-type: none"> <li>· Crown - Recently crown reduced</li> <li>· Crown - Weak branch Unions</li> <li>· Trunk - Forked trunk</li> <li>· Trunk - Weak unions</li> <li>· Trunk - Exudation</li> </ul> | None Recorded. | No action required | T1 on previous report. Tag 001729. Mature Elm in fair structural condition and good physiological condition. The tree has recently been reduced as recommended in previous report, with new shoots starting to emerge. Tight branch unions at 1.25m and 2.5m and co-dominant leaders. The union at 1.25m was sound tested with a soft faced hammer and probed with no significant signs of decay detected. Sap runs also present under these two lowest unions. No works currently required. | 01/04/2029 |

T1: Forked trunk

T1: Trunk - Exudation

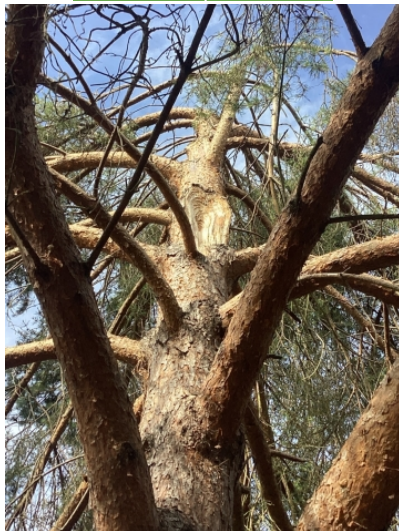
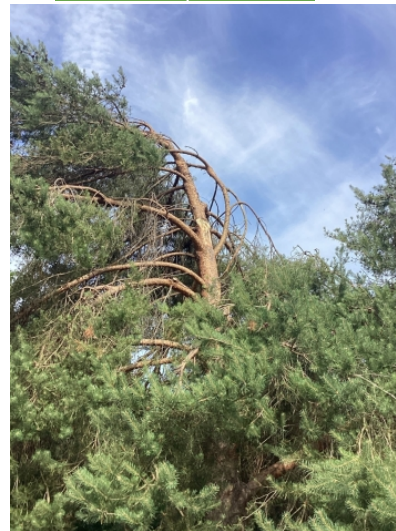
Seq: 3

| Seq No | Tree Position | Common Name | Bat PRFs | Height (m) | Age | Stru cond. | Conditions | Recommendations | Priority | Comments | Next S/T Inspect |
|---|---|---|---|---|---|---|---|---|---|---|---|
| 3 | Adjacent entrance to 'Parsonage House' | Pine spp | No | 10 | Mature | Fair | · Trunk - 2x Trunk wounds on upper stem, tear out wound from storm damage. | · Re-inspect in 18 months to ensure structural integrity. | 18 months | T3 on last report. Mature Pine tree in fair structural condition and good physiological condition. The tree suffered an upper stem tear out in winter 2024/25, with 2 wounds visible at approximately 6-7m. No fungi observed and tapping with a soft faced hammer infers no decay up to 2m on stem. The tree appears to have responded well to the tear out failure with new growth. No works currently required. | 01/10/2027 |

T3: Trunk wound

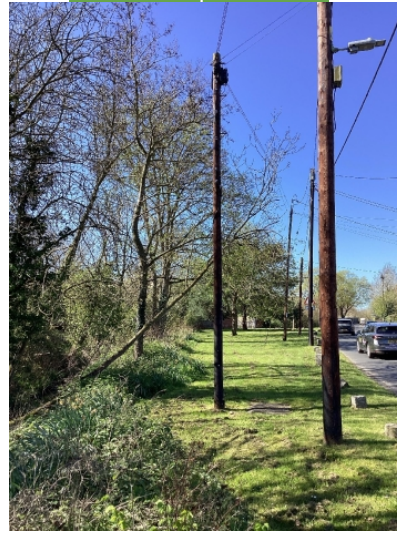
Seq: 4

| Seq No | Tree Position | Common Name | Bat PRFs | Height (m) | Age | Stru cond. | Conditions | Recommendations | Priority | Comments | Next S/T Inspect |
|---|---|---|---|---|---|---|---|---|---|---|---|
| 4 | Opposite no. 90 School Lane | Common Ash | No | 10 | Semi-mature | Poor | · Trunk - Major trunk decay | · Fell Tree to Ground Level | Within 30 days | Ash tree in poor structural condition and good physiological condition. The stem has failed at the base and is now resting on adjacent overhead utility cables with the highway within falling distance. | |

T4: Fell Tree to Ground Level

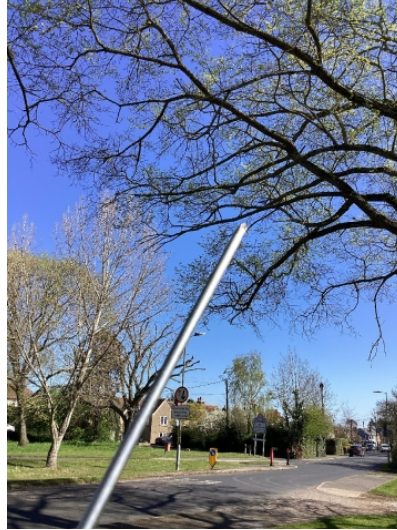
Seq: 5

| Seq No | Tree Position | Common Name | Bat PRFs | Height (m) | Age | Stru cond. | Conditions | Recommendations | Priority | Comments | Next S/T Inspect |
|---|---|---|---|---|---|---|---|---|---|---|---|
| 5 | Outside The Old Goose Yard | Elm spp | No | 14 | Mature | Good | <ul style="list-style-type: none"> <li>· Crown - Major Deadwood &gt;5cm diam/1m length</li> <li>· Crown - Previous crown reduction to S aspect back from adjacent building, with around 1m regrowth.</li> </ul> | <ul style="list-style-type: none"> <li>· Remove Deadwood &gt;5cm diam/1m length over highway and footway</li> </ul> | Within 90 days | Tag 001739. Mature Elm in good overall condition. Large diameter deadwood present, as to be expected with age and shading of lower branches. | 01/04/2029 |

T5: Remove Deadwood >5cm diam/1m length

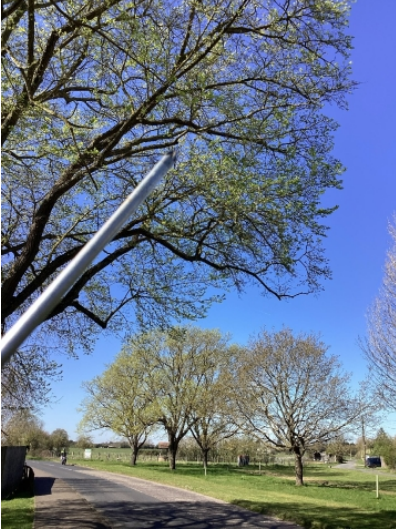
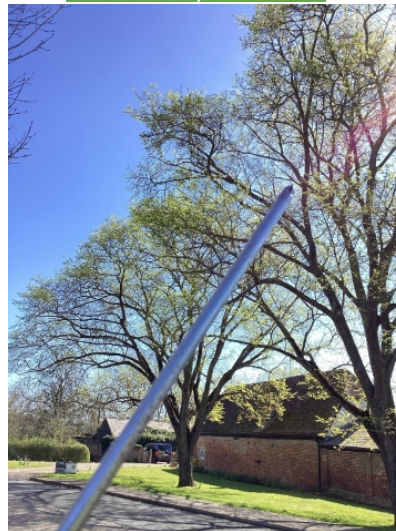
Seq: 6

| Seq No | Tree Position | Common Name | Bat PRFs | Height (m) | Age | Stru cond. | Conditions | Recommendations | Priority | Comments | Next S/T Inspect |
|---|---|---|---|---|---|---|---|---|---|---|---|
| 6 | Outside The Old Goose Yard barn | Elm spp | No | 15 | Mature | Good | <ul style="list-style-type: none"> <li>· Crown - Major Deadwood &gt;5cm diam/1m length</li> <li>· Crown - Previous crown reduction to S aspect back from adjacent building, with around 1m regrowth.</li> </ul> | <ul style="list-style-type: none"> <li>· Remove Deadwood &gt;5cm diam/1m length over highway and footway x2</li> </ul> | Within 90 days | Tag 001740. Mature Elm in good overall condition. Large diameter deadwood present, as to be expected with age and shading of lower branches. | 01/04/2029 |

T6: Remove Deadwood >5cm diam/1m length
