# Broomfield Parish Council

## Agenda

- 1.1 A site visit was carried out by Adam Sultan (Place Services' Arboricultural Consultant) on 7<sup>th</sup> April 2026 to inspect trees in line with the instruction from Broomfield Parish Council. Unless otherwise stated, all trees were inspected visually from ground level. The nature of the survey was to assess the site for risks from tree-related hazards and to recommend any necessary work to control these risks.

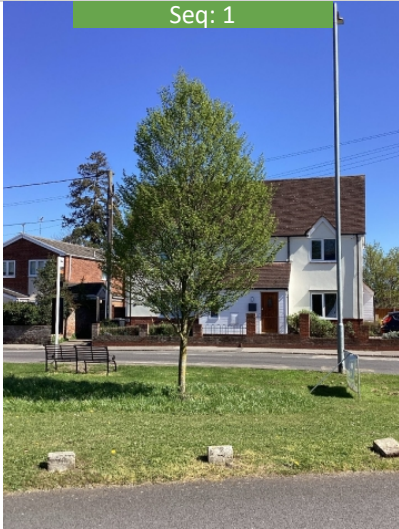
Seq: 1

| Seq No | Tree Position | Common Name | Bat PRFs | Height (m) | Age | Stru cond. | Conditions | Recommendations | Priority | Comments | Next S/T Inspect |
|---|---|---|---|---|---|---|---|---|---|---|---|
| 1 | Opposite 172 | Hornbeam | No | 5 | Young | Good | · No significant defects<br>· No works required | None Recorded. | No action required | G1 on previous report. Young Hornbeam in good overall condition. Tree guard and basal/ lower stem epicormic growth has been removed since last inspection as recommended. | 01/04/2029 |

T1: Hornbeam

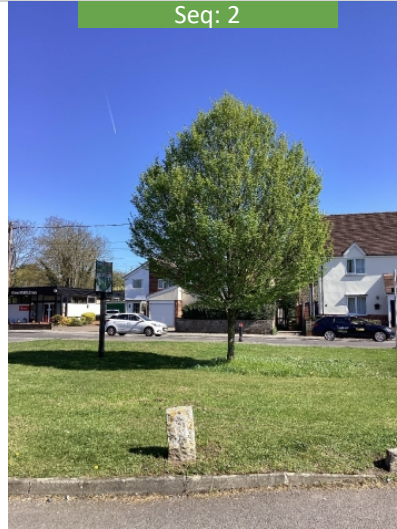
Seq: 2

| Seq No | Tree Position | Common Name | Bat PRFs | Height (m) | Age | Stru cond. | Conditions | Recommendations | Priority | Comments | Next S/T Inspect |
|---|---|---|---|---|---|---|---|---|---|---|---|
| 2 | Adjacent Broomfield sign | Hornbeam | No | 6 | Young | Good | · No significant defects<br>· No works required | None Recorded. | No action required | G1 on previous report. Young Hornbeam in good overall condition. Tree guard and basal/ lower stem epicormic growth has been removed since last inspection as recommended. | 01/04/2029 |

T2: Hornbeam

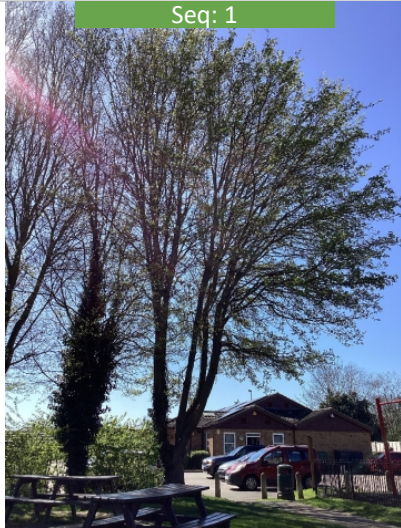
| Seq No | Tree Position | Common Name | Bat PRFs | Height (m) | Age | Stru cond. | Conditions | Recommendations | Priority | Comments | Next S/T Inspect |
|---|---|---|---|---|---|---|---|---|---|---|---|
| 1 | Adjacent play area, green bin, car park, benches | Sycamore | No | 12 | Mature | Fair | · Trunk - Weak union<br>· Trunk - Compression fork<br>· Trunk - Included bark - probe can currently be inserted 5cm | Re-inspect compression fork union | 18 months | T1 on previous report. Mature tree in fair structural condition and good physiological condition. The tree has a compression fork at the crown break at 1.7m, with included bark, a probe can currently be inserted 5cm. There is a high target of the play area and footpath, due to this it is recommended to monitor the union before the next scheduled inspection to assess structural integrity. | 01/11/2027 |

T1: Sycamore

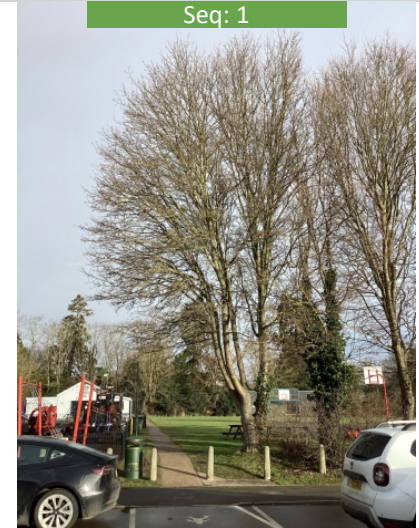
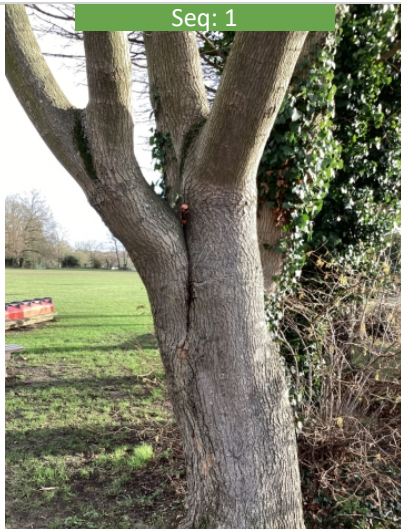
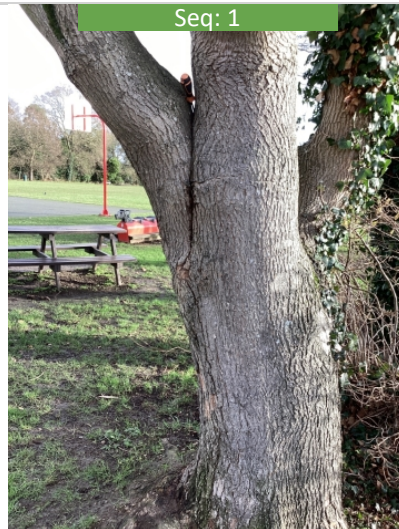
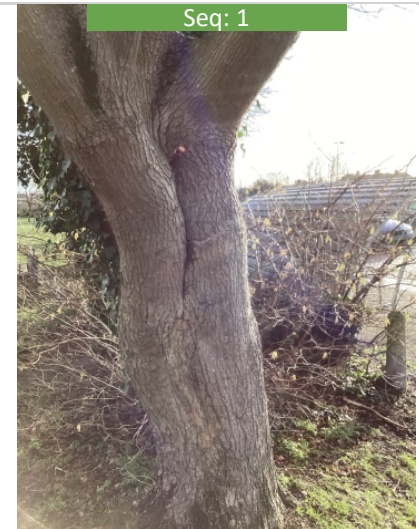
T1: Previous inspection 27/01/2025

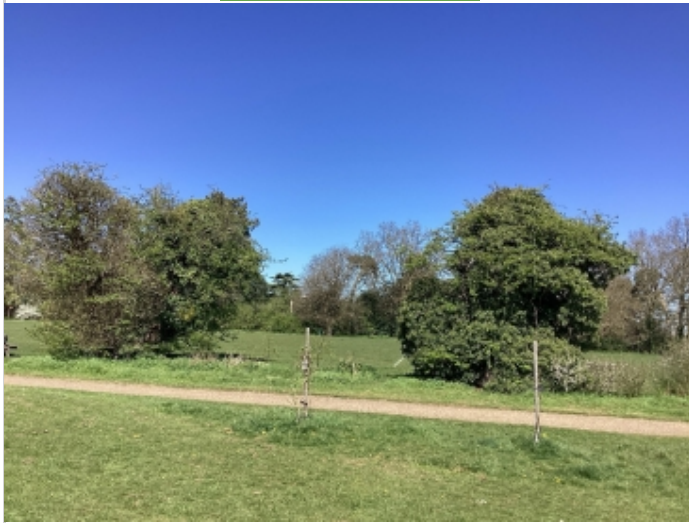
| Seq No | Tree Position | Common Name | Bat PRFs | Height (m) | Age | Stru cond. | Conditions | Recommendations | Priority | Comments | Next S/T Inspect |
|---|---|---|---|---|---|---|---|---|---|---|---|
| H2 | Both sides of halfway line | Mixed Broadleaves | No | 6 | Mature | Fair | · Trunk - Ivy | None Recorded. | No action required | Group of 2 Hawthorn and 2 Elder trees in good physiological condition. Both trees are heavily ivy clad, preventing a full stem inspection. Ivy has been severed as recommend at last inspection, however this is only beginning to die back. | 01/04/2029 |

G1: 2x Hawthorn, 2x Elder

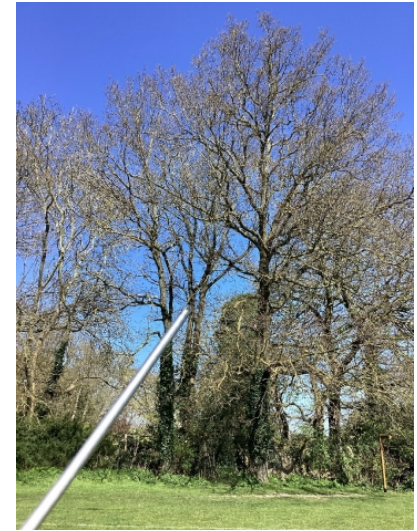
Seq: 3

| Seq No | Tree Position | Common Name | Bat PRFs | Height (m) | Age | Stru cond. | Conditions | Recommendations | Priority | Comments | Next S/T Inspect |
|---|---|---|---|---|---|---|---|---|---|---|---|
| 3 | Off site adjacent T2 Horse Chestnut on previous report | Common Ash | Yes | 16 | Semi-mature | Poor | <ul style="list-style-type: none"> <li>· Crown - Major Deadwood &gt;5cm diam/1m length</li> <li>· Trunk - Major trunk decay</li> <li>· Trunk - Cavity</li> <li>· Trunk - Fungus</li> </ul> | <ul style="list-style-type: none"> <li>· Further Investigation</li> </ul> | Within 30 days | <p>Off site twin stem Ash tree in poor structural condition and fair physiological condition.</p> <p>Multiple woodpecker holes visible along both stems, with <i>Inonotus hispidus</i> (shaggy bracket) wood decay fungi also present, these factors are likely to have caused significant internal decay along the stems, however due to boundary fence no further assessment can be made at present.</p> <p>It is recommended to contact the landowner and request they commission a full inspection of the tree and carry out necessary works as the tree is within falling distance of the public footpath and playing field.</p> | 01/04/2029 |

T3: Ash

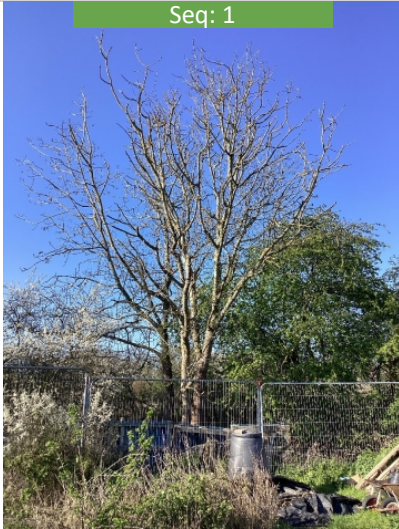
Seq: 1

| Seq No | Tree Position | Common Name | Bat PRFs | Height (m) | Age | Stru cond. | Conditions | Recommendations | Priority | Comments | Next S/T Inspect |
|---|---|---|---|---|---|---|---|---|---|---|---|
| 1 | NW corner of allotments | Common Ash | No | 11 | Semi-mature | Fair | <ul style="list-style-type: none"><li>· Crown - Major Deadwood &gt;5cm diam/1m length</li><li>· Crown - Dieback in upper crown, suspected Ash dieback</li><li>· Ash Health Class 3 - 50% -25% Canopy</li></ul> | <ul style="list-style-type: none"><li>· Remove Deadwood &gt;5cm diam/1m length overhanging allotments</li></ul> | Within 90 days | T1 on previous report. Multi-stem Ash tree in fair overall condition. The tree has suspected Ash dieback, negatively impacting crown vitality, with some deadwood present. Remove deadwood on allotment side of the tree. | 01/04/2029 |

T1: Ash

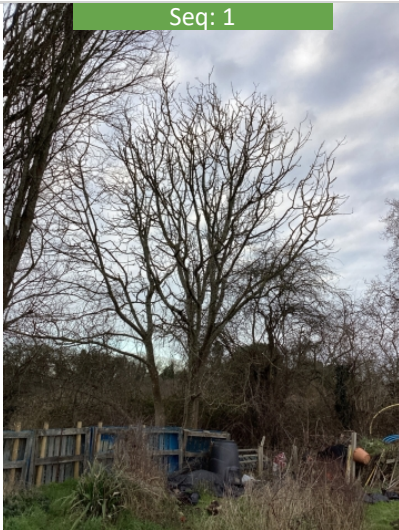
Seq: 1

T1: Previous inspection 24/01/2025

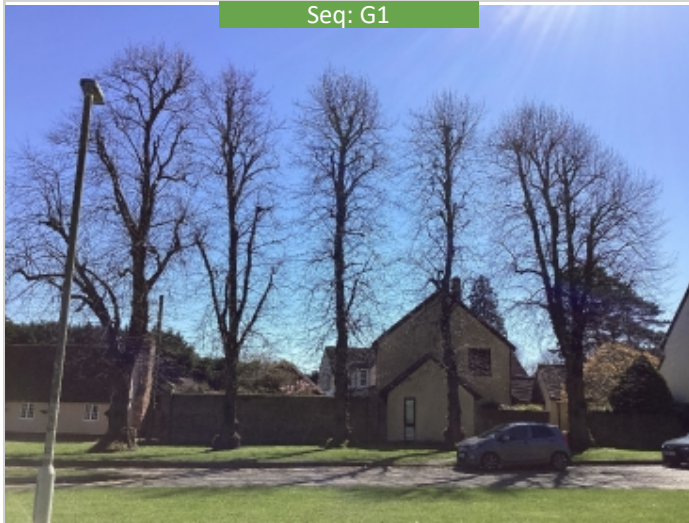
Seq: G1

| Seq No | Tree Position | Common Name | Bat PRFs | Height (m) | Age | Stru cond. | Conditions | Recommendations | Priority | Comments | Next S/T Inspect |
|---|---|---|---|---|---|---|---|---|---|---|---|
| G1 | Opposite pedestrian entrance to church | Common Lime | No | 13 | Mature | Good | · Crown - Pollard | · Re-pollard in winter 2027/28 (x 5 trees) | Within 2 years | G1 on previous report. Group of 5 mature Lime trees in good overall condition. Basal growth has recently been pruned back. The trees are on a 5 year pollarding maintenance cycle, currently with approximately 3m of re-growth, typical for this species and this is to be maintained. | 01/04/2029 |

G1: 5x Lime

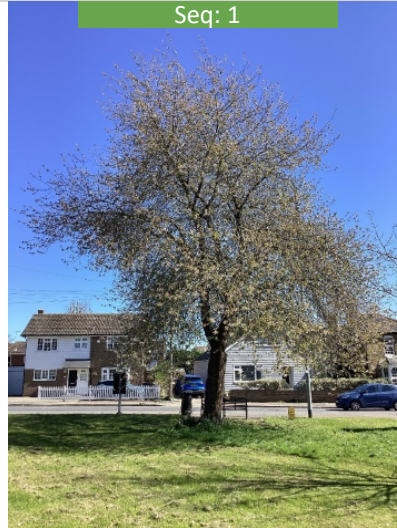
Seq: 1

| Seq No | Tree Position | Common Name | Bat PRFs | Height (m) | Age | Stru cond. | Conditions | Recommendations | Priority | Comments | Next S/T Inspect |
|---|---|---|---|---|---|---|---|---|---|---|---|
| 1 | Adjacent bus stop / black bench | Wild Cherry | No | 11 | Mature | Fair | · Crown - Weak branch Unions | None Recorded. | No action required | T1 on previous report. Mature Cherry tree in fair structural condition with good crown vitality. The tree has recently been crown lifted over the footway as recommended in the previous report. The tree has included bark at the crown break at 2.5m to the S aspect, this is a potential failure point, however at present there is no indication of significant decay when sound tested with a soft faced hammer and probed. No work currently required. | 01/04/2029 |

T1: Cherry

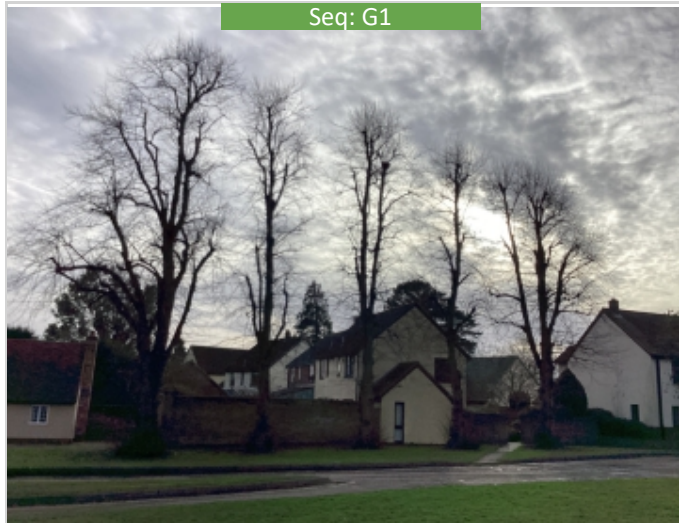
Seq: G1

G1: Previous inspection 24/01/2025

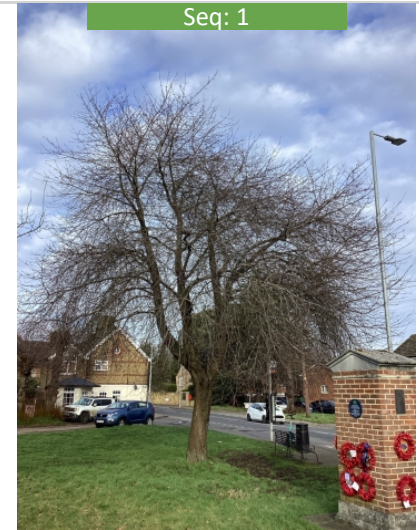
Seq: 1

T1: Previous inspection 24/01/2025

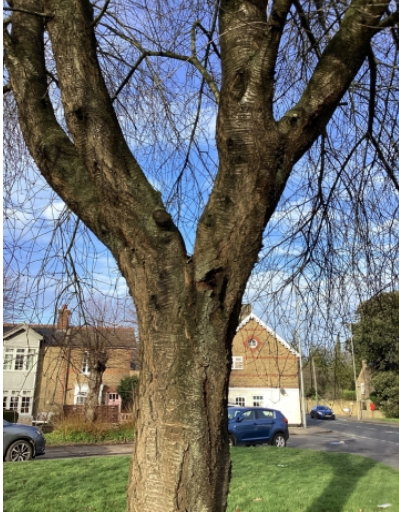
Seq: 1

T1: Previous inspection of weak union 24/01/2025

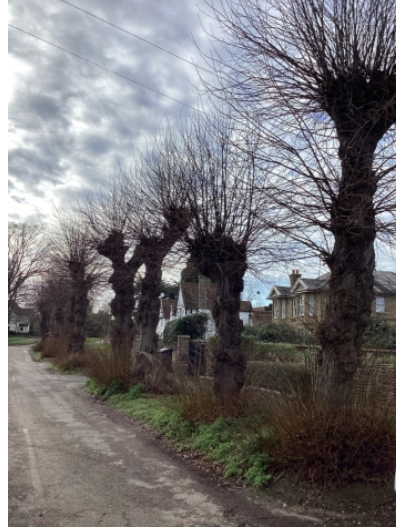
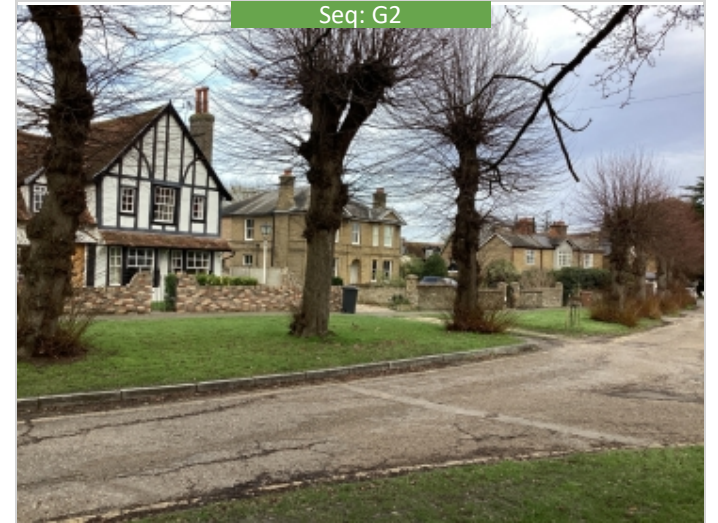
| Seq No | Tree Position | Common Name | Bat PRFs | Height (m) | Age | Stru cond. | Conditions | Recommendations | Priority | Comments | Next S/T Inspect |
|---|---|---|---|---|---|---|---|---|---|---|---|
| G2 | Outside 2-18 | Common Lime | No | 6 | Mature | Good | · No significant defects<br>· No works required | None Recorded. | No action required | G2 on previous report. Group of 11 mature Lime trees in good overall condition. All trees have recently had their basal epicormic growth removed and also recently been re-pollarded. The trees are on a pollarding maintenance cycle every 3-5 years and this is to be maintained. No works currently required. | 01/04/2029 |

G2: Previous inspection 24/01/2025

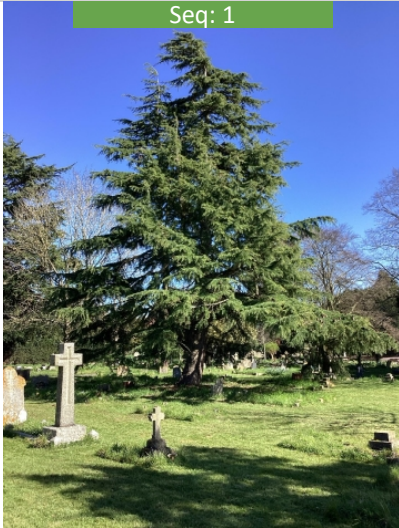
Seq: 1

| Seq No | Tree Position | Common Name | Bat PRFs | Height (m) | Age | Stru cond. | Conditions | Recommendations | Priority | Comments | Next S/T Inspect |
|---|---|---|---|---|---|---|---|---|---|---|---|
| 1 | Centre of Church Yard | Deodar Cedar | No | 12 | Mature | Fair | <ul style="list-style-type: none"> <li>· Crown - Broken hanging branches</li> <li>· Crown - Low branches over graves</li> </ul> | <ul style="list-style-type: none"> <li>· Crown Lift to 3m all round if unrestricted access is required.</li> <li>· Remove broken hanging branches x2</li> </ul> | <p>Within 1 year</p> <p>Within 30 days</p> | <p>Tag 0588. Mature Cedar in fair structural condition and good physiological condition.</p> <p>There are multiple broken branches within the crown, no fungi or disease visually evident on inspection. There are low drooping branches over graves, consistent with the species, an optional crown lift all round to 3m will abate this obstruction if unrestricted access is required in this area.</p> | 01/04/2029 |

T1: Cedar

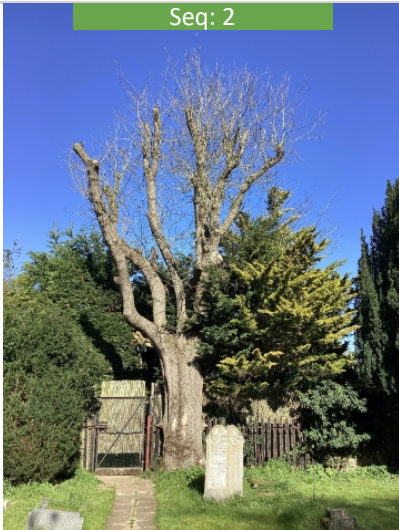
Seq: 2

| Seq No | Tree Position | Common Name | Bat PRFs | Height (m) | Age | Stru cond. | Conditions | Recommendations | Priority | Comments | Next S/T Inspect |
|---|---|---|---|---|---|---|---|---|---|---|---|
| 2 | End of path, adjacent gate | Common Ash | No | 12 | Mature | Poor | <ul style="list-style-type: none"><li>· Crown - Pollard</li><li>· Crown - Significant decay visible on branch growing into adjacent hedge</li><li>· Crown - Fungus - <i>Inonotus hispidus</i> bracket on leading stem 1.5m above crown break</li><li>· Minor trunk decay - Tapping stem from base up to 2m infers minimal decay at present.</li><li>· Trunk - Fungus - <i>Perenniporia fraxinea</i> brackets around all aspects of buttress.</li></ul> | <ul style="list-style-type: none"><li>· Re-inspect in 18 months to assess decay and observe any new fungi.</li></ul> | 18 months | Mature Ash in poor structural condition and fair physiological condition.<br><br>The tree has <i>Perenniporia fraxinea</i> (Giant Ash bracket) fungi brackets around all aspects of buttress. Tapping stem from base up to 2m infers minimal decay at present. Significant branch decay visible on branch growing into adjacent hedge. <i>Inonotus hispidus</i> (Shaggy bracket) bracket on leading stem 1.5m above crown break. The tree has been pollarded, suspected due to fungi and potential structural weakness, with sporadic poor regrowth up to 2m. | 01/10/2027 |

T2: Ash

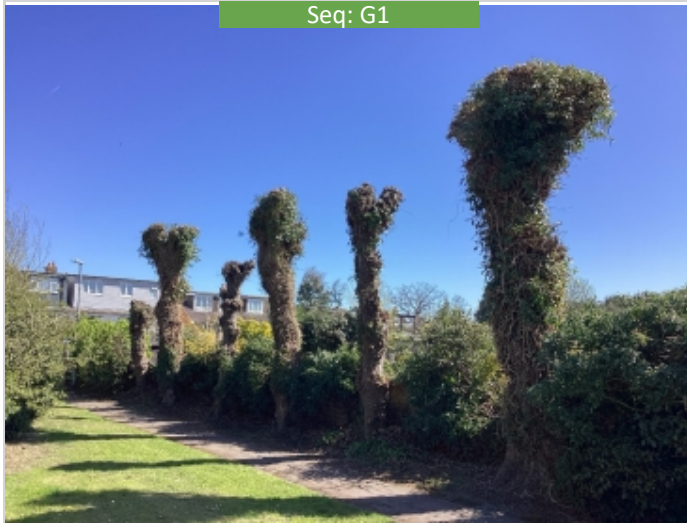
Seq: G1

| Seq No | Tree Position | Common Name | Bat PRFs | Height (m) | Age | Stru cond. | Conditions | Recommendations | Priority | Comments | Next S/T Inspect |
|---|---|---|---|---|---|---|---|---|---|---|---|
| G1 | South side of footpath | Mixed Broadleaves | No | 5 | Mature | Good | · Crown - Recently pollarded in winter 2025/26<br><br>· Trunk - Ivy | None Recorded. | No action required | G1 on previous report. Group of 6 (3 Lime, 3 London Plane) mature trees, in good physiological condition. Ivy has been severed as recommended on previous report, however it is still dying back preventing a full stem inspection. The trees have recently been pollarded and this maintenance cycle should be maintained every 3-5 years. | 01/04/2029 |

G1: G1: 3x lime, 3x London Plane

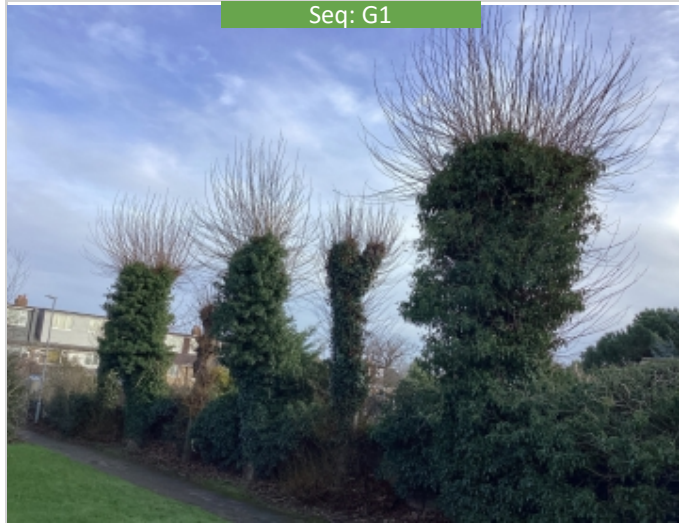
Seq: G1

G1: Previous inspection 24/01/2025

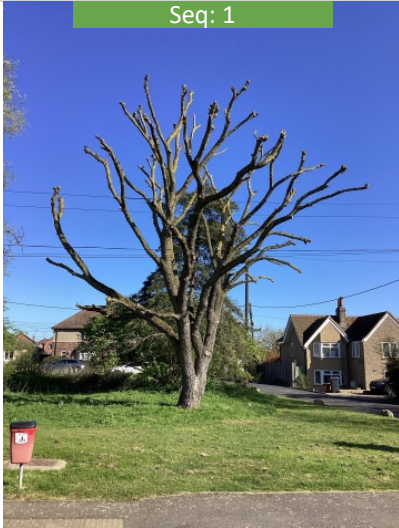
Seq: 1

| Seq No | Tree Position | Common Name | Bat PRFs | Height (m) | Age | Stru cond. | Conditions | Recommendations | Priority | Comments | Next S/T Inspect |
|---|---|---|---|---|---|---|---|---|---|---|---|
| 1 | Approximately 10m NW of Broomfield sign | Elm spp | No | 12 | Mature | Fair | <ul style="list-style-type: none"> <li>· Crown - Recently crown reduced</li> <li>· Crown - Weak branch Unions</li> <li>· Trunk - Forked trunk</li> <li>· Trunk - Weak unions</li> <li>· Trunk - Exudation</li> </ul> | None Recorded. | No action required | T1 on previous report. Tag 001729. Mature Elm in fair structural condition and good physiological condition. The tree has recently been reduced as recommended in previous report, with new shoots starting to emerge. Tight branch unions at 1.25m and 2.5m and co-dominant leaders. The union at 1.25m was sound tested with a soft faced hammer and probed with no significant signs of decay detected. Sap runs also present under these two lowest unions. No works currently required. | 01/04/2029 |

T1: Elm

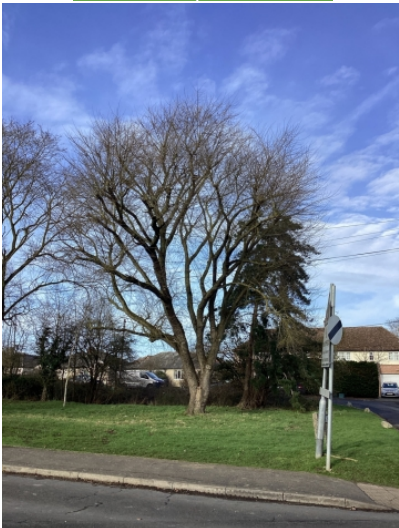
Seq: 1

T1: Previous inspection 24/01/2025

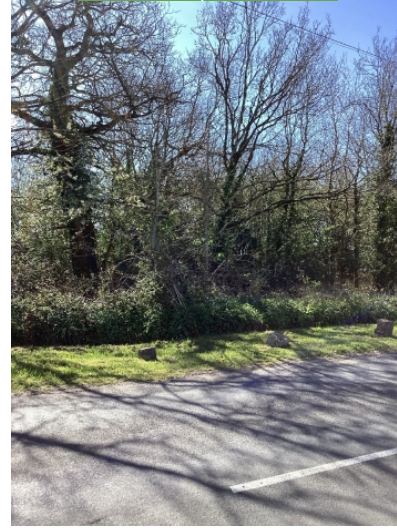
Seq: G1

G1: 2x Elm

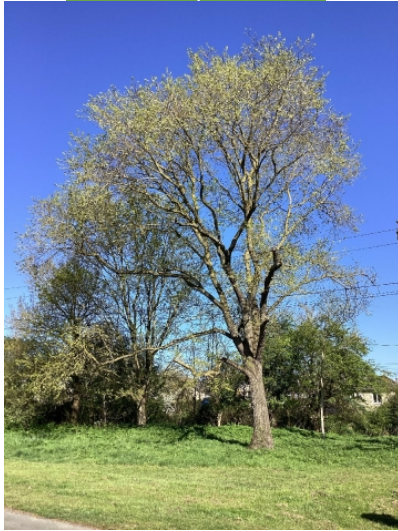
Seq: 2

| Seq No | Tree Position | Common Name | Bat PRFs | Height (m) | Age | Stru cond. | Conditions | Recommendations | Priority | Comments | Next S/T Inspect |
|---|---|---|---|---|---|---|---|---|---|---|---|
| 2 | Approximately 10m NW of red dog poo bin | Elm spp | No | 15 | Mature | Good | <ul style="list-style-type: none"> <li>· Crown - Previous crown reduction to the Southern aspect back from overhead utilities.</li> <li>· No works required</li> </ul> | None Recorded. | No action required | T2 on previous report. Tag 001728. Mature Elm in good overall condition. Branches to the South aspect have recently been pruned back from overhead utilities as recommend on previous report. No works currently required. | 01/04/2029 |

T2: Elm

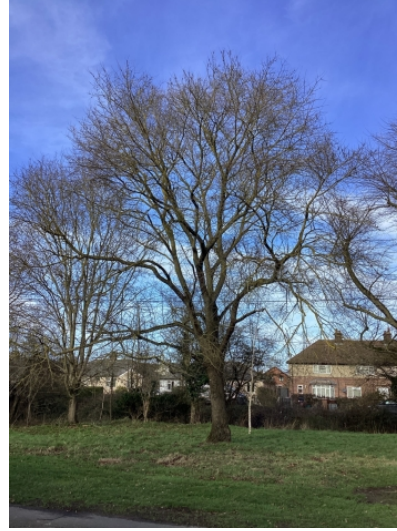
Seq: 2

T2 : Previous inspection 24/01/2025

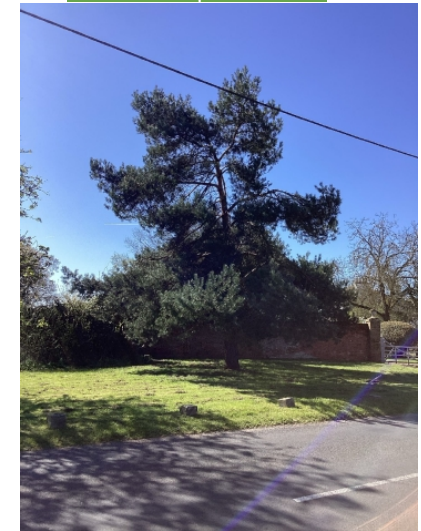
Seq: 3

| Seq No | Tree Position | Common Name | Bat PRFs | Height (m) | Age | Stru cond. | Conditions | Recommendations | Priority | Comments | Next S/T Inspect |
|---|---|---|---|---|---|---|---|---|---|---|---|
| 3 | Adjacent entrance to 'Parsonage House' | Pine spp | No | 10 | Mature | Fair | · Trunk - 2x Trunk wounds on upper stem, tear out wound from storm damage. | · Re-inspect in 18 months to ensure structural integrity. | 18 months | T3 on last report. Mature Pine tree in fair structural condition and good physiological condition. The tree suffered an upper stem tear out in winter 2024/25, with 2 wounds visible at approximately 6-7m. No fungi observed and tapping with a soft faced hammer infers no decay up to 2m on stem. The tree appears to have responded well to the tear out failure with new growth. No works currently required. | 01/10/2027 |

T3: Pine

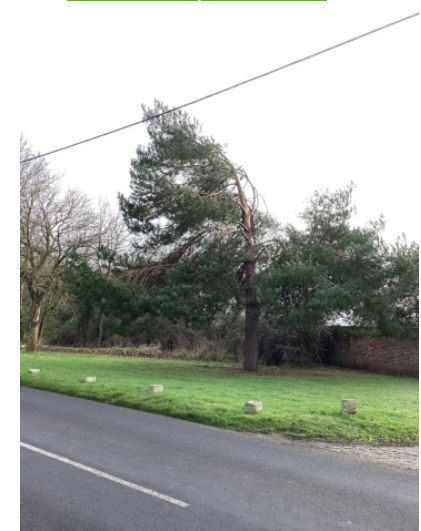
Seq: 3

T3: Previous inspection 24/01/2025

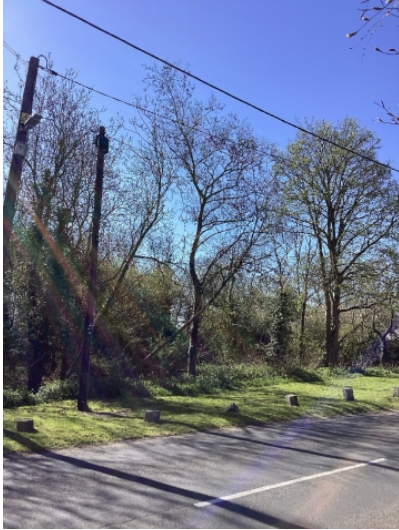
Seq: 4

| Seq No | Tree Position | Common Name | Bat PRFs | Height (m) | Age | Stru cond. | Conditions | Recommendations | Priority | Comments | Next S/T Inspect |
|---|---|---|---|---|---|---|---|---|---|---|---|
| 4 | Opposite no. 90 School Lane | Common Ash | No | 10 | Semi-mature | Poor | · Trunk - Major trunk decay | · Fell Tree to Ground Level | Within 30 days | Ash tree in poor structural condition and good physiological condition. The stem has failed at the base and is now resting on adjacent overhead utility cables with the highway within falling distance. | |

T4: Ash

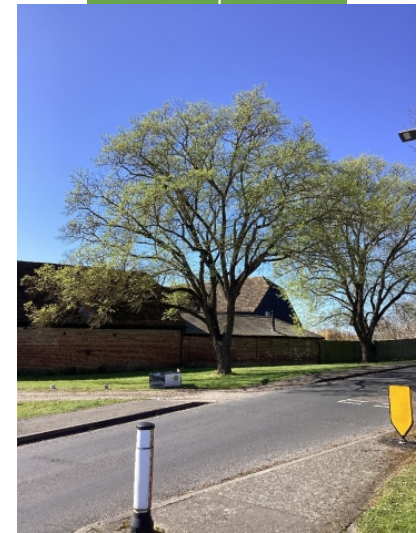
Seq: 5

| Seq No | Tree Position | Common Name | Bat PRFs | Height (m) | Age | Stru cond. | Conditions | Recommendations | Priority | Comments | Next S/T Inspect |
|---|---|---|---|---|---|---|---|---|---|---|---|
| 5 | Outside The Old Goose Yard | Elm spp | No | 14 | Mature | Good | <ul style="list-style-type: none"> <li>· Crown - Major Deadwood &gt;5cm diam/1m length</li> <li>· Crown - Previous crown reduction to S aspect back from adjacent building, with around 1m regrowth.</li> </ul> | <ul style="list-style-type: none"> <li>· Remove Deadwood &gt;5cm diam/1m length over highway and footway</li> </ul> | Within 90 days | Tag 001739. Mature Elm in good overall condition. Large diameter deadwood present, as to be expected with age and shading of lower branches. | 01/04/2029 |

T5: Elm

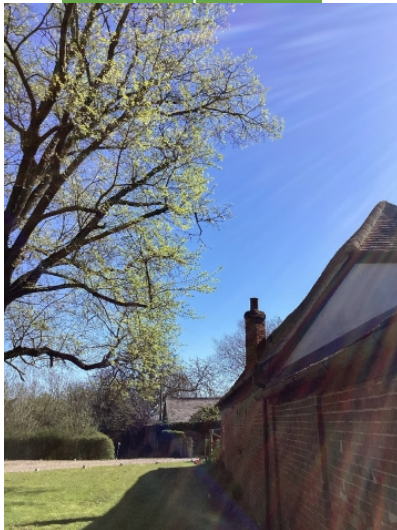
Seq: 5

T5: Previous crown reduction to S

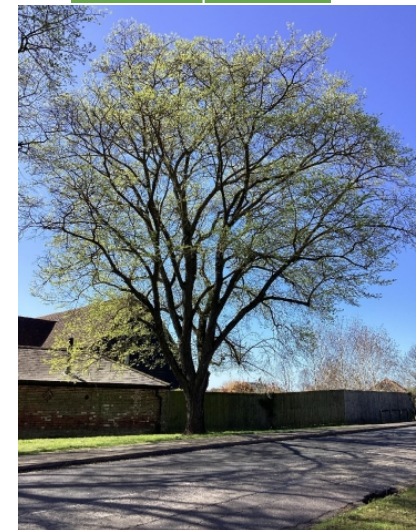
Seq: 6

| Seq No | Tree Position | Common Name | Bat PRFs | Height (m) | Age | Stru cond. | Conditions | Recommendations | Priority | Comments | Next S/T Inspect |
|---|---|---|---|---|---|---|---|---|---|---|---|
| 6 | Outside The Old Goose Yard barn | Elm spp | No | 15 | Mature | Good | <ul style="list-style-type: none"> <li>· Crown - Major Deadwood &gt;5cm diam/1m length</li> <li>· Crown - Previous crown reduction to S aspect back from adjacent building, with around 1m regrowth.</li> </ul> | <ul style="list-style-type: none"> <li>· Remove Deadwood &gt;5cm diam/1m length over highway and footway x2</li> </ul> | Within 90 days | Tag 001740. Mature Elm in good overall condition. Large diameter deadwood present, as to be expected with age and shading of lower branches. | 01/04/2029 |

T6: Elm
